Presentation Overview

Remediation System Layout

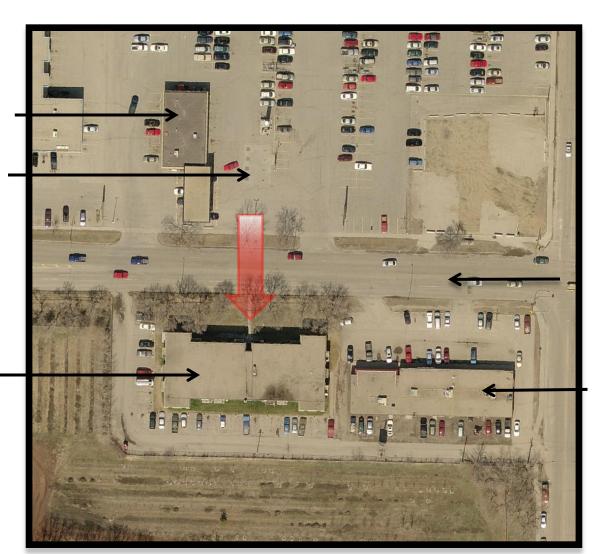
Fuel Facility

Tank Nest

Apartment Building

33rd Street

Commercial Strip Mall

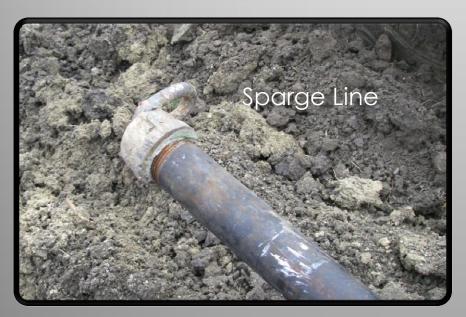
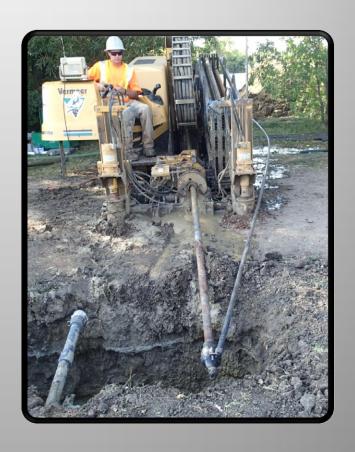
Specialty Tooling

- Well Development
 - 1,000 L of water
 - 500 L of 3% 5% Hydrogen Peroxide Solution
- Sand Tremme 10/20 Filter Sand
- Bentonite/Cement Grout Seal

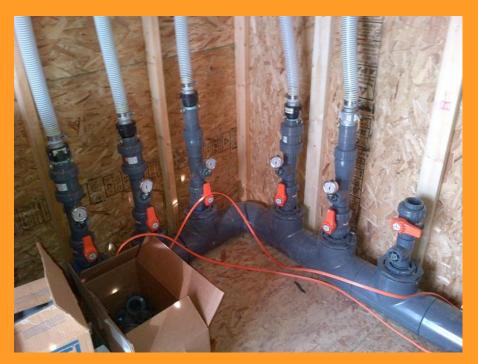
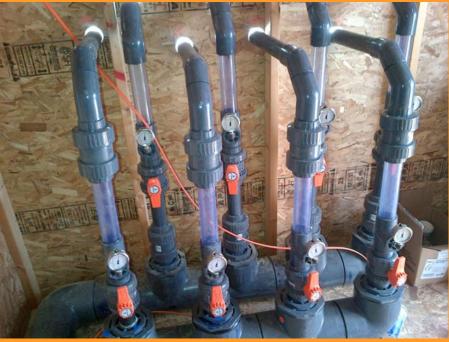
Dewatering Well Assessment

- Similar silt load observed during the initial operation
- Silt diminished shortly after operation

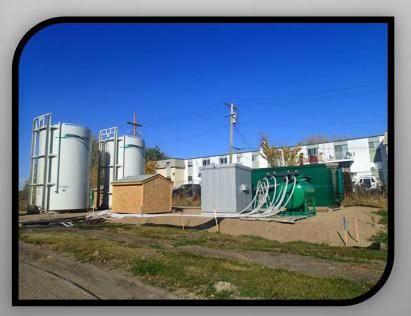
Remediation Results

- MPVE operational period: October 2013 to May 2014
- Total Groundwater Recovered 730,000 L
- Total PHC Mass Recovered 9,000 Kg
